Study On Highway Roadside Safety Prabhat Chauraha to Bajrang Chauraha Raisen Road Bhopal

Road Safety Issues of “Prabhat Chauraha to Bajrang Chauraha” Raisen Road Highway, Bhopal

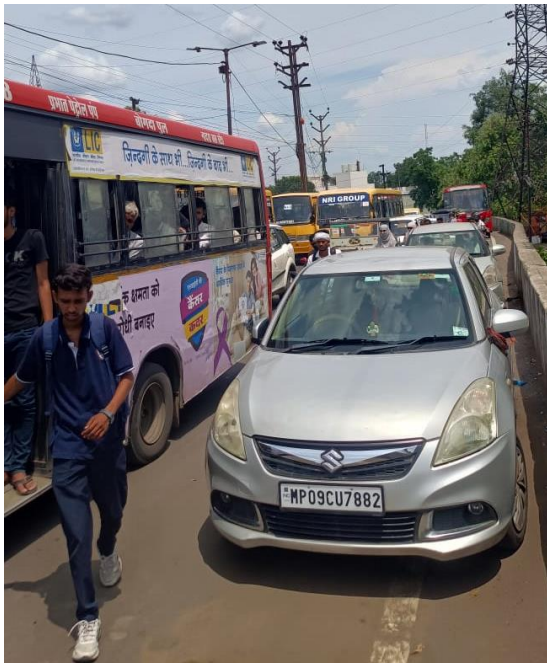
Figure 1 Photo of Raisen Road Highway (Near Anand Nagar, Bhopal)

Experiences heavy traffic congestion, especially during peak hours in morning time 9:00 am to 11:00 am and evening time 5:00 pm to 7:00 pm leading to delays and frustration among commuters. The high volume of vehicles, coupled with inadequate road infrastructure, exacerbates congestion issues and increases the likelihood of accidents.

This photograph shows the critical concern about the traffic congestion in raisen road Bhopal. This is also inconvenience to the road user.

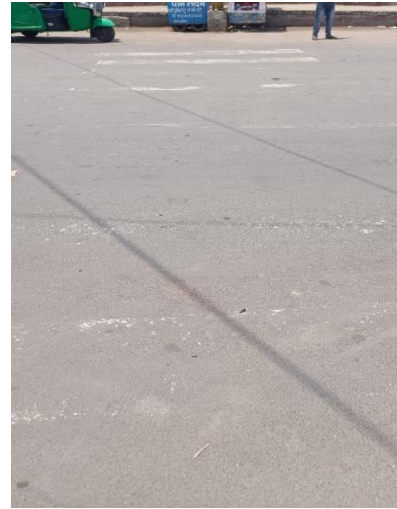
Figure 2 Photo of Raisen Road Highway (Near Old Subhash Nagar, Govindpura, Bhopal)

Lack of Pedestrian Facilities (As per “IRC:103-2012”): The road lacks proper pedestrian facilities such as footpaths, crosswalks, and pedestrian signals, posing significant risks to pedestrians. Without designated areas for pedestrians to walk safely, they are forced to navigate through traffic, increasing their vulnerability to accidents.

The Photograph captures a critical concern as lack of visibility in zebra crossing.

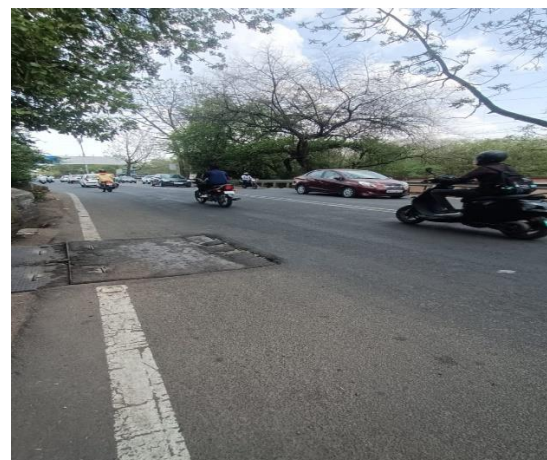
Figure 3 Photo of Raisen Road Highway (Near JK Road, CPRI Colony, Bhopal)

Unsafe Intersection (As per “IRC:SP:041”): Some intersections along Raisen Road have poorly designed layouts or lack proper signage and signals, leading to confusion and unsafe maneuvers by drivers. Inadequate intersection design increases the likelihood of rear-end collisions, side-swipes, and other accidents.

This picture shows the unavailability of road signs just before the intersection and uneven surface.

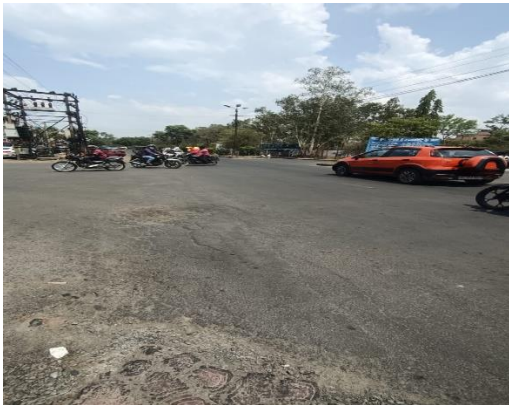
Figure 4 Photo of Raisen Road Highway (Near Punjabi Bagh Colony, Bhopal)

Poor Road Maintenance (As per “IRC:82-2015”): Sections of Raisen Road may suffer from potholes, uneven surfaces, and other road defects due to inadequate maintenance. These conditions not only cause discomfort to drivers but also increase the risk of accidents, especially for two-wheeler riders.

In this photograph show the uneven surface, this causes the vehicle damage and increases the travel time.

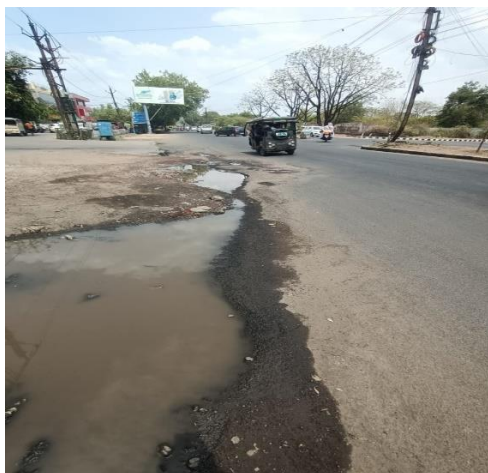
Figure 5 Photo of Raisen Road Highway (Indrapuri C-Sector, Bhopal)

This photograph captured a critical concern about the pot hole holds the water damage in raisen road highway.

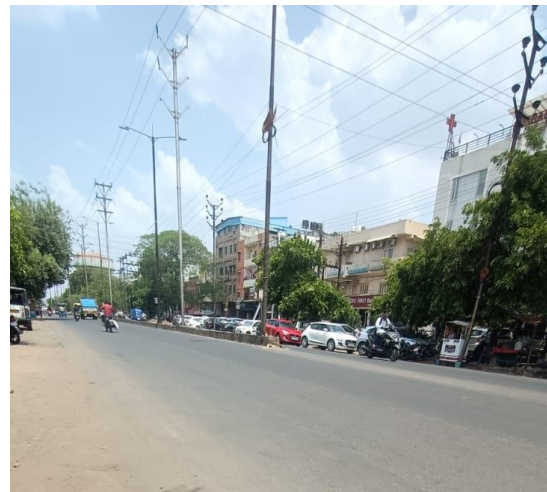
Figure 6 Photo of Raisen Road Highway (Near CPRI Colony, Bhopal)

Encroachments and Illegal Parking (As per “IRC:SP:12-2015”): Illegal encroachments onto the road space and unauthorized parking along Raisen Road obstruct traffic flow and visibility, creating hazardous conditions for motorists and pedestrians alike.

This photograph shows illegal parking in this road and it is inconvenience to the road user.
